FEBRUARY 21, 2022 // FACILITIES ASSESSMENT

OKEMOS PUBLIC SCHOOLS

TowerPinkster
ARCHITECTURE • ENGINEERING • INTERIOR

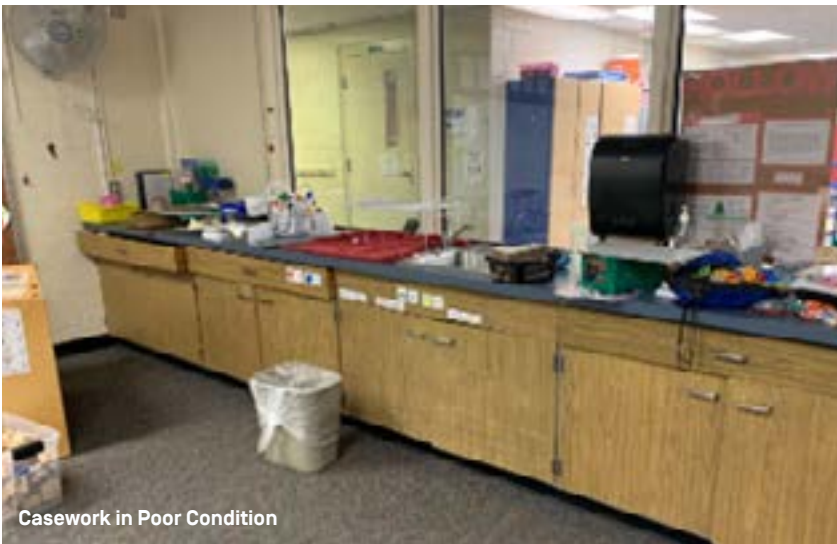
Casework in Poor Condition

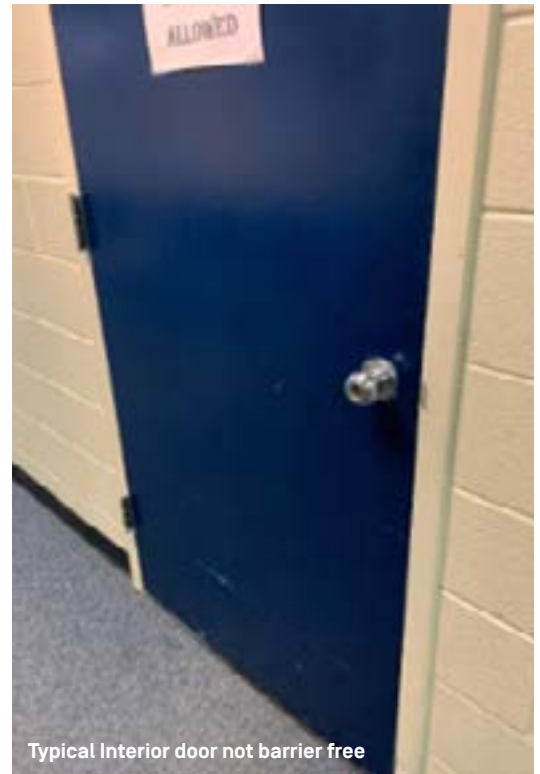
Typical Interior door not barrier free

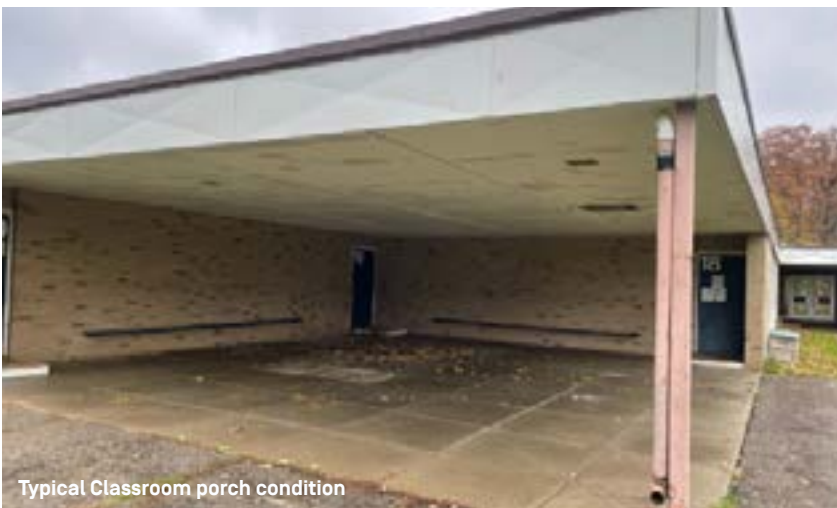
Typical Classroom porch condition

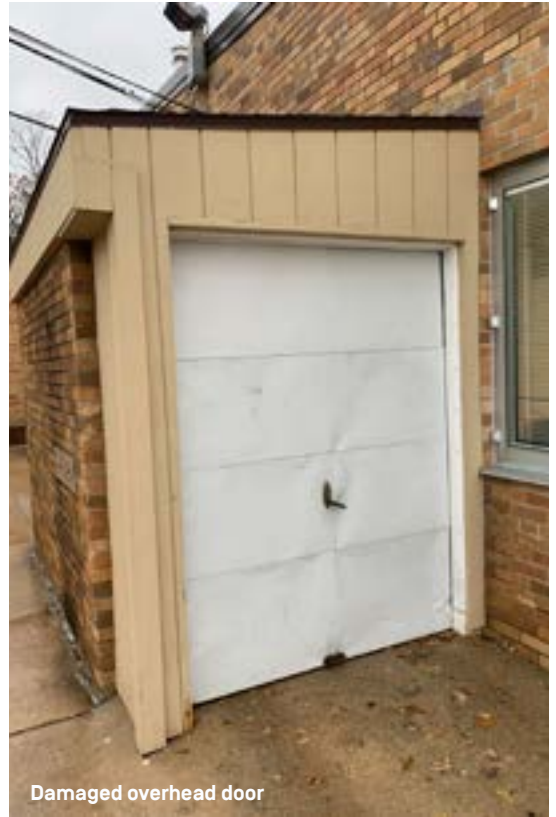
Damaged overhead door

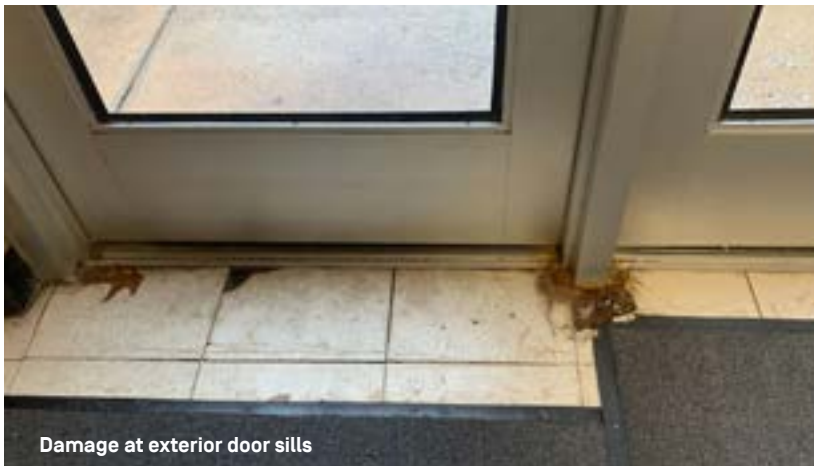
Damage at exterior door sills

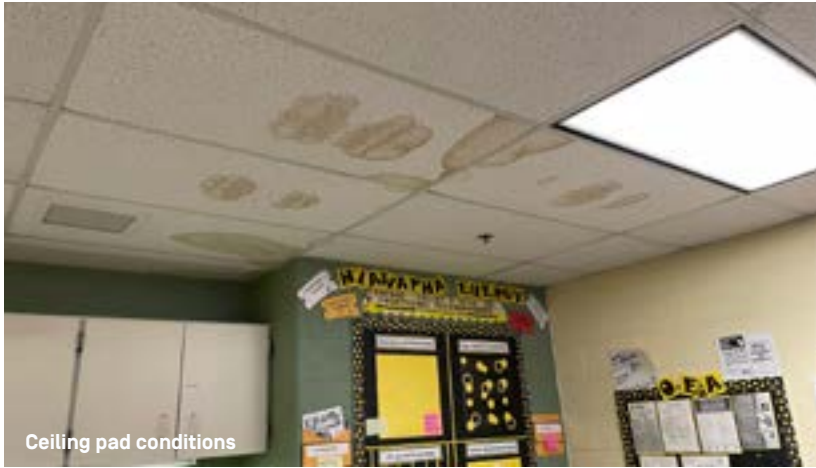
Ceiling pad conditions

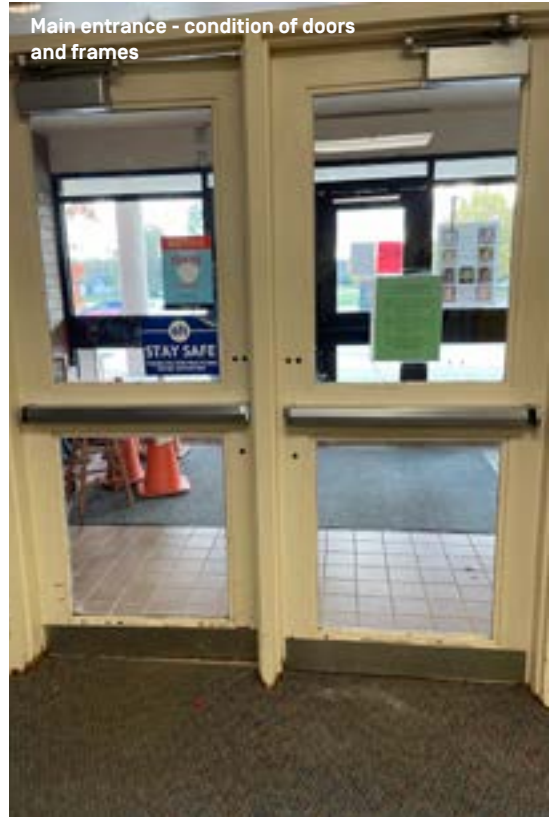
Main entrance - condition of doors and frames

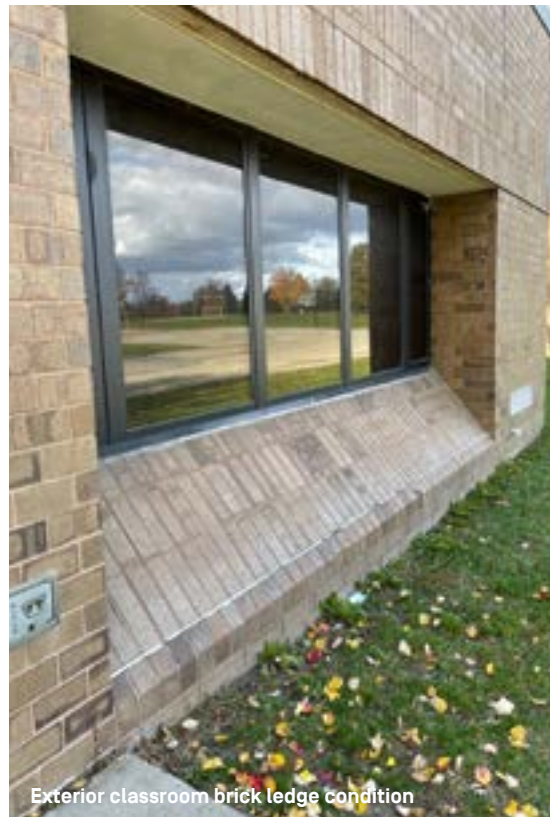
Exterior classroom brick ledge condition

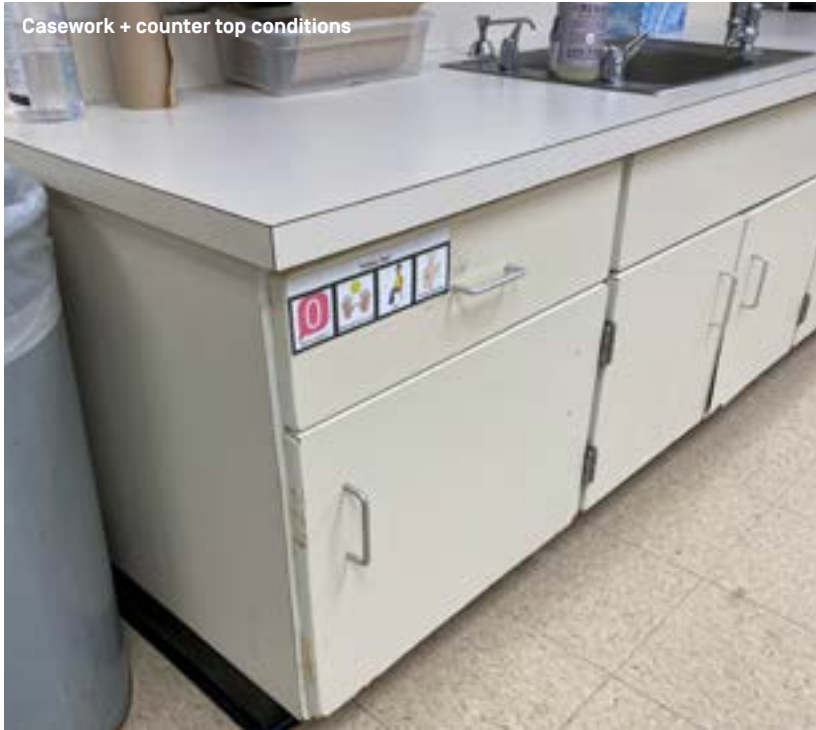
Casework + counter top conditions

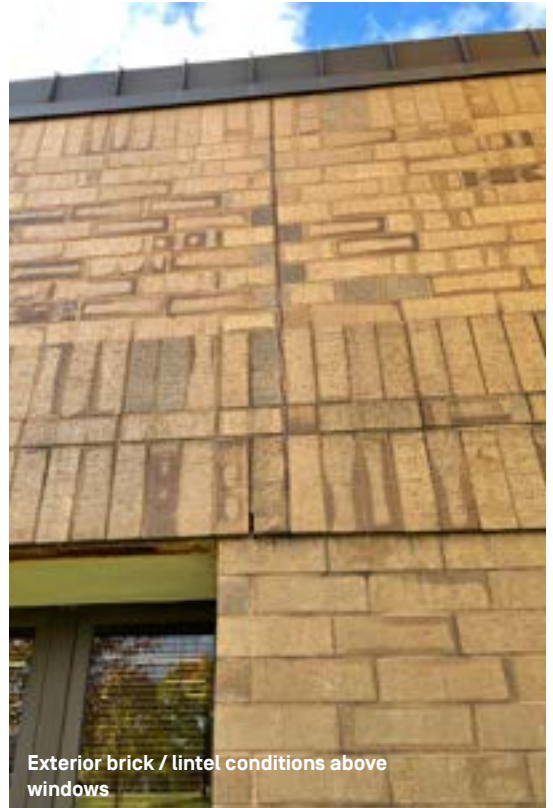
Exterior brick / lintel conditions above windows

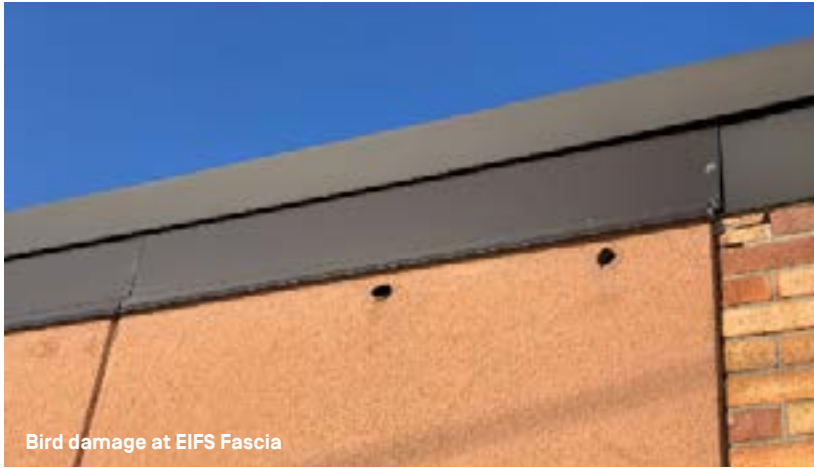
Bird damage at EIFS Fascia

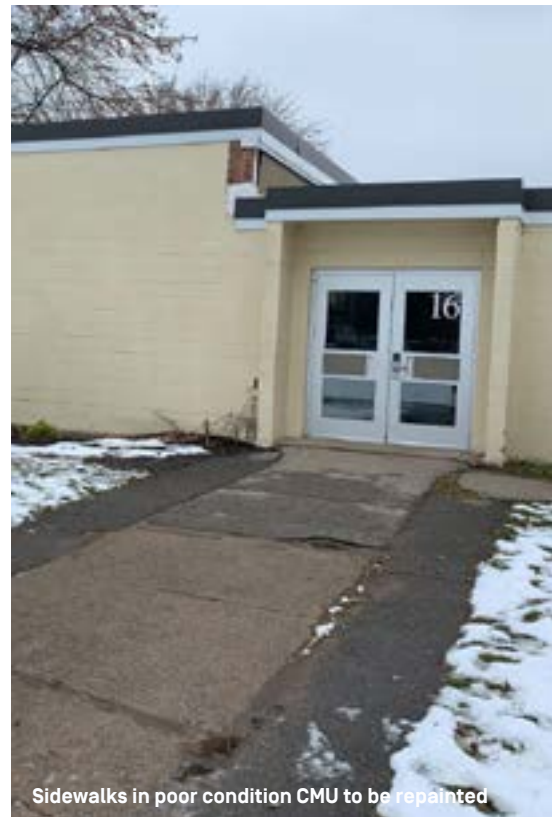
Sidewalks in poor condition CMU to be repainted

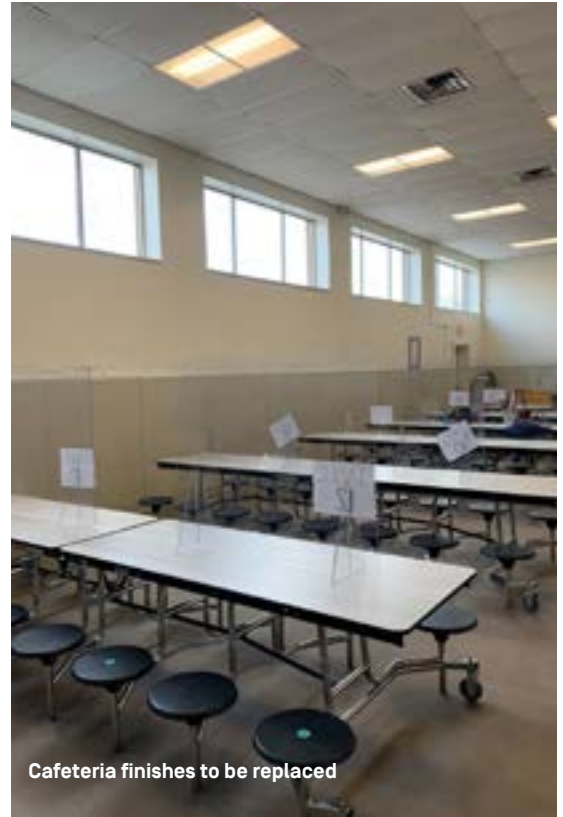
Cafeteria finishes to be replaced

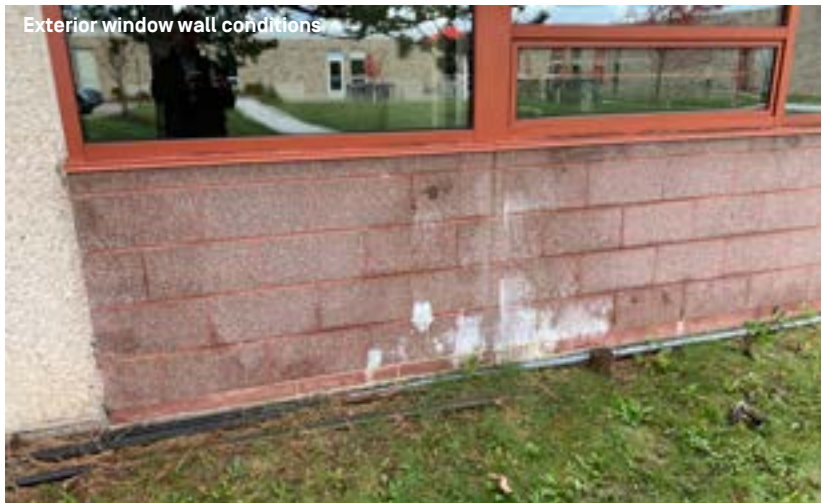
Exterior window wall conditions

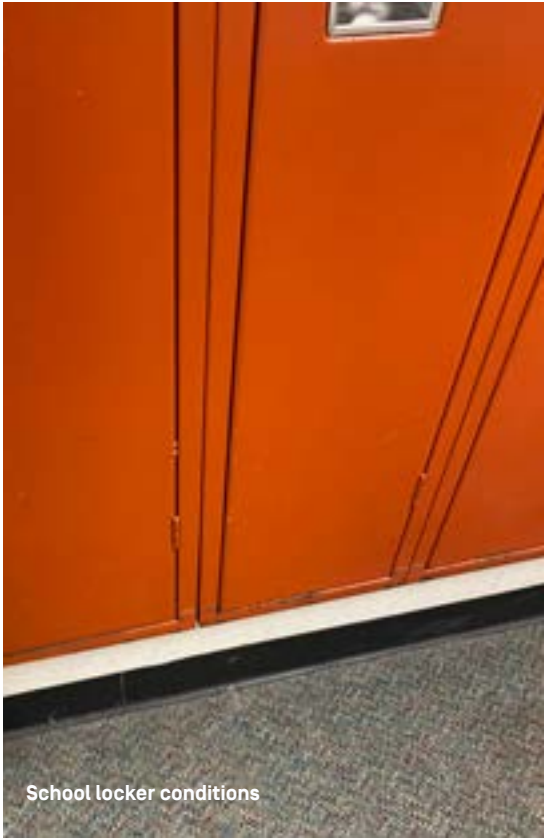
School locker conditions

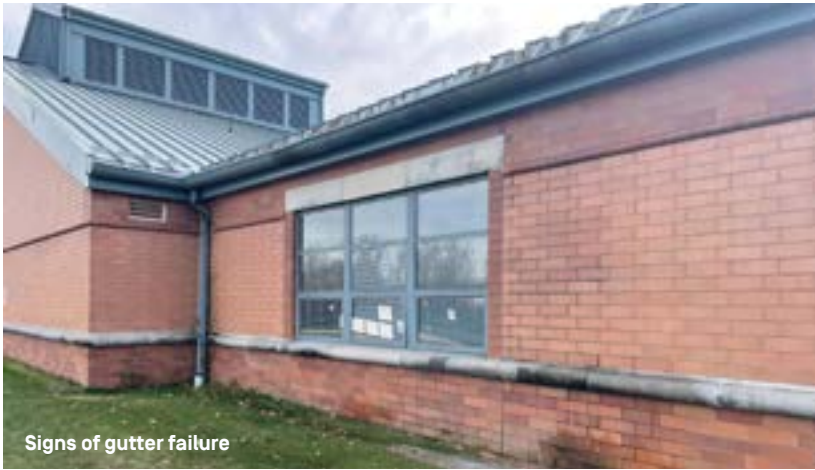
Signs of gutter failure

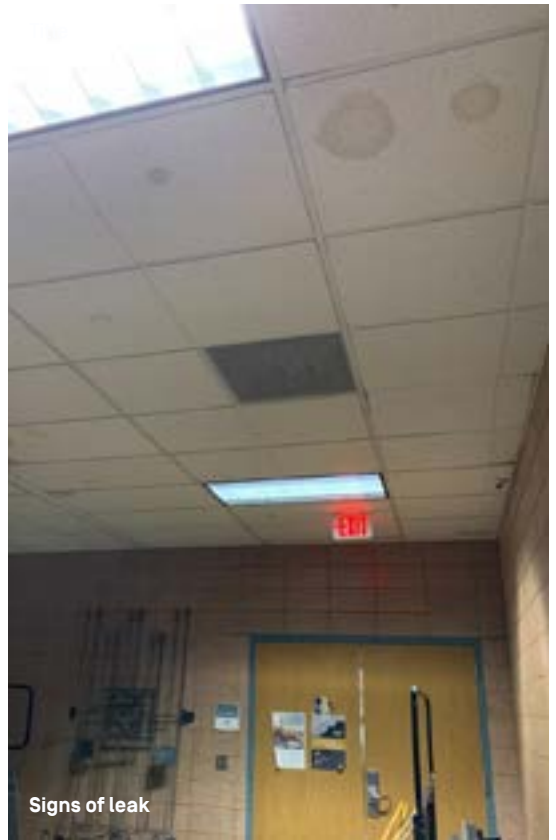
Signs of leak

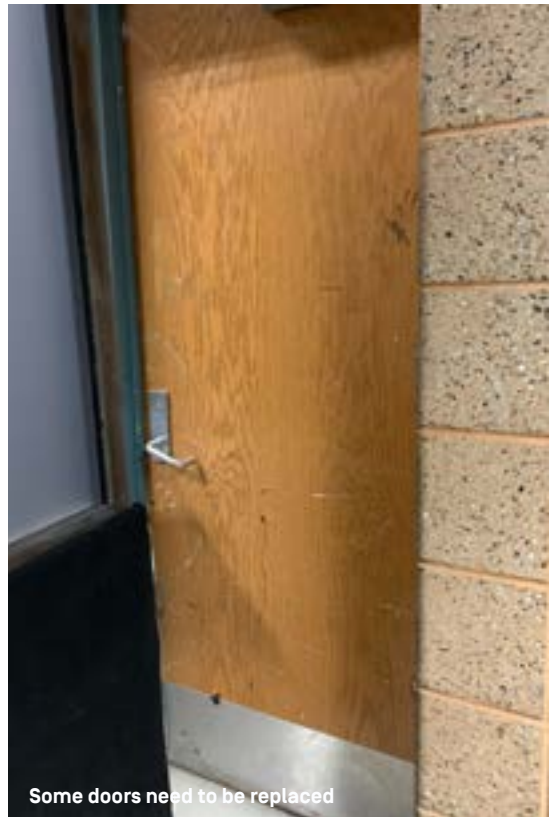
Some doors need to be replaced

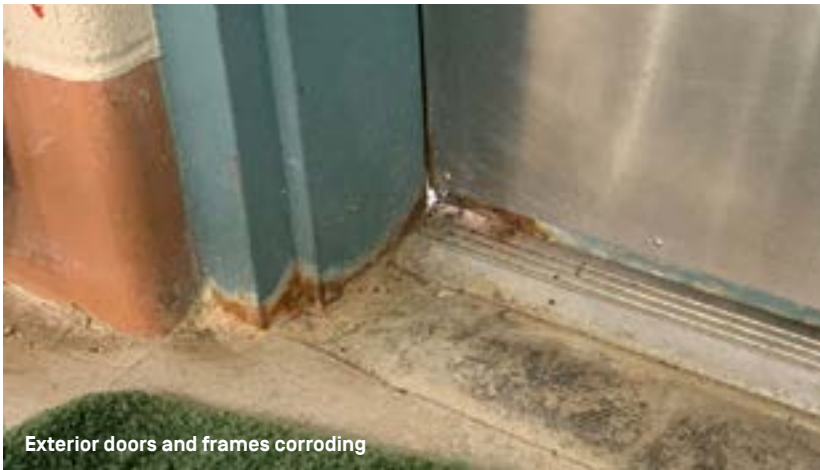
Exterior doors and frames corroding

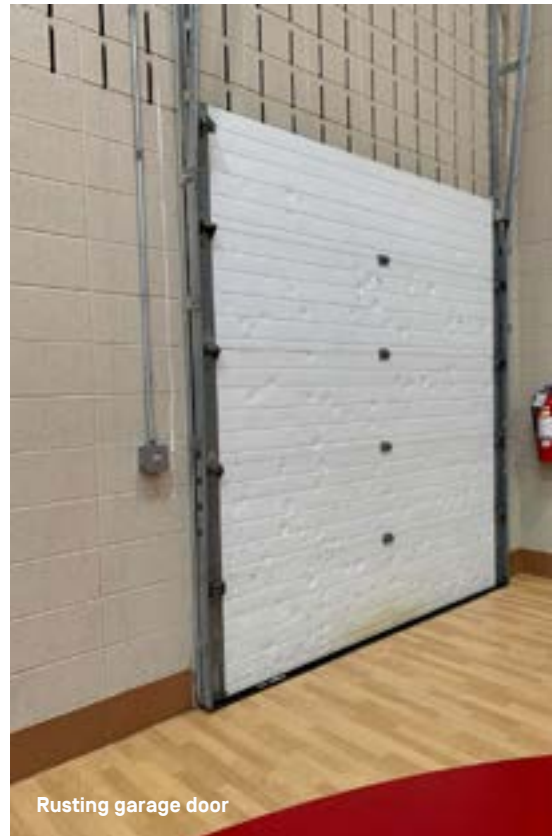
Rusting garage door

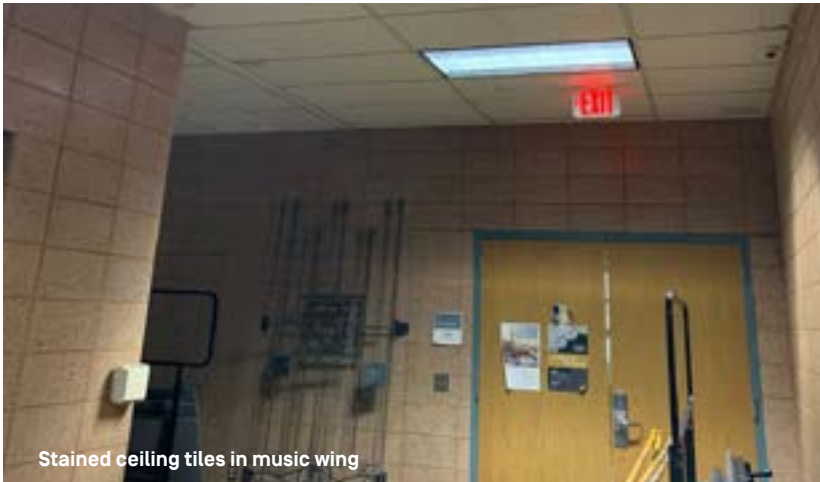
Stained ceiling tiles in music wing

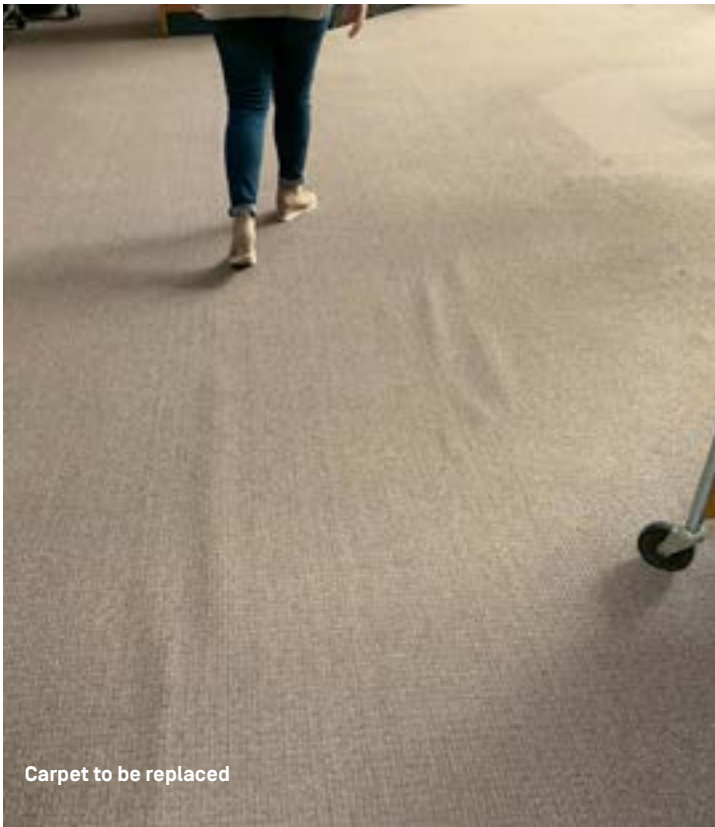
Carpet to be replaced

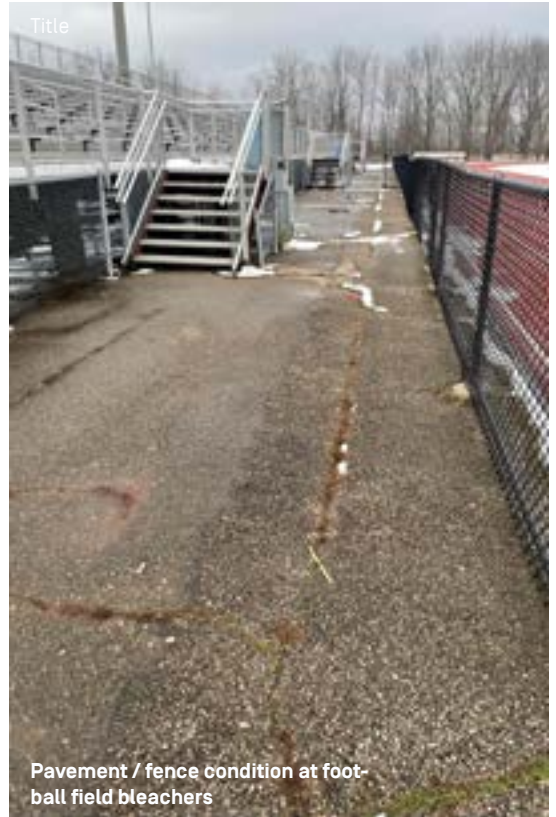
Pavement / fence condition at football field bleachers

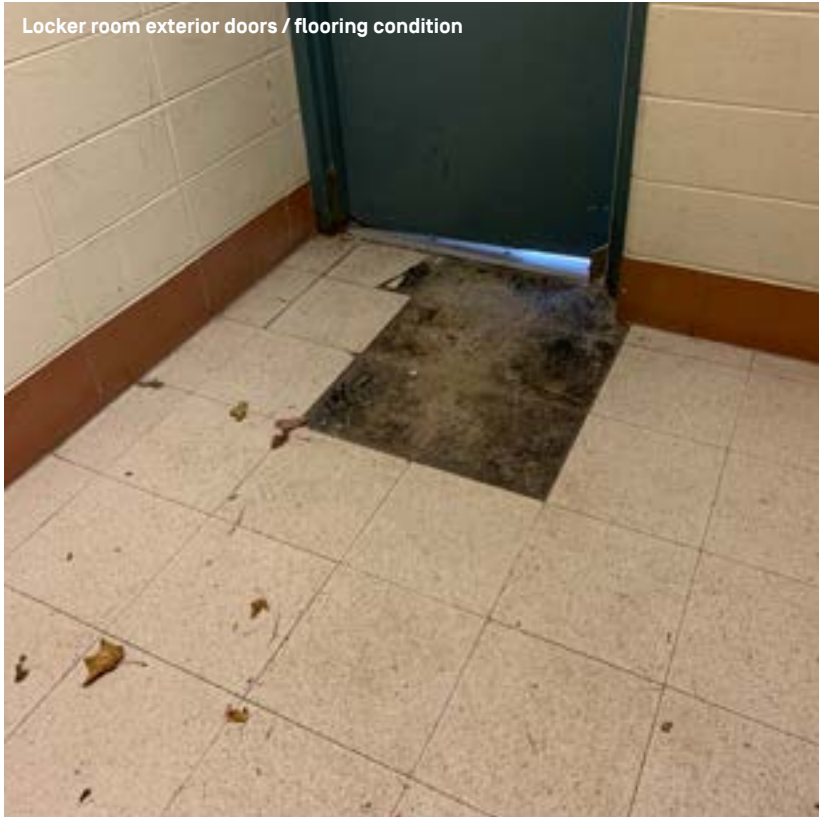
Locker room exterior doors / flooring condition

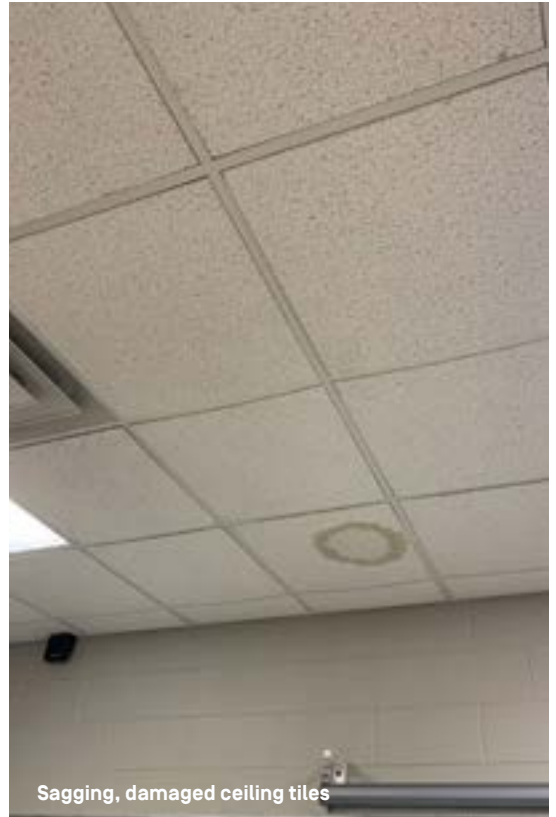
Sagging, damaged ceiling tiles

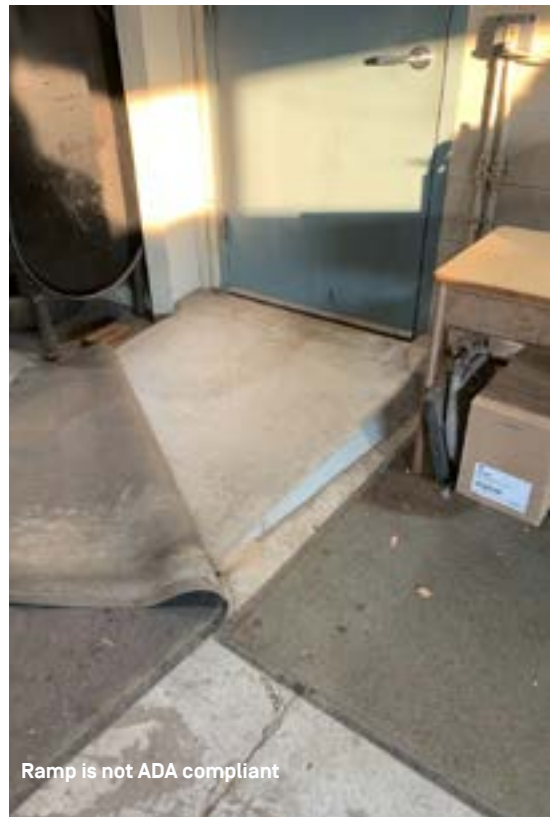
Ramp is not ADA compliant

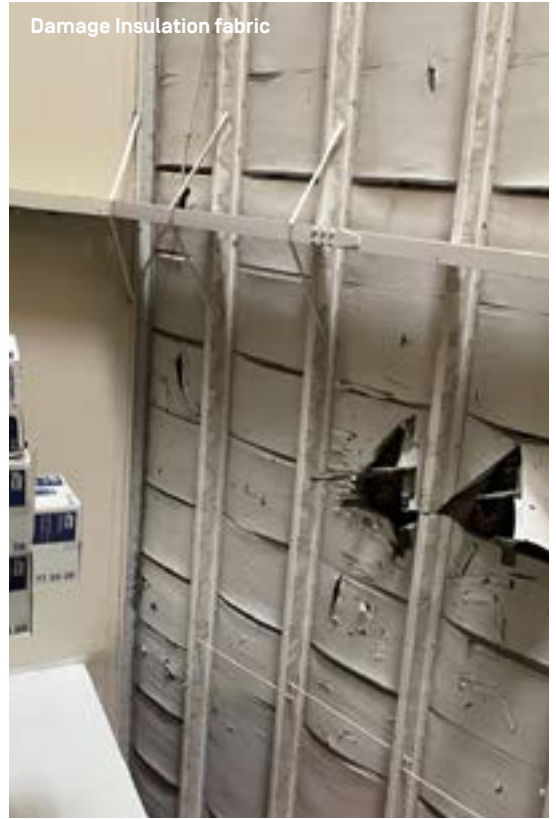
Damage Insulation fabric

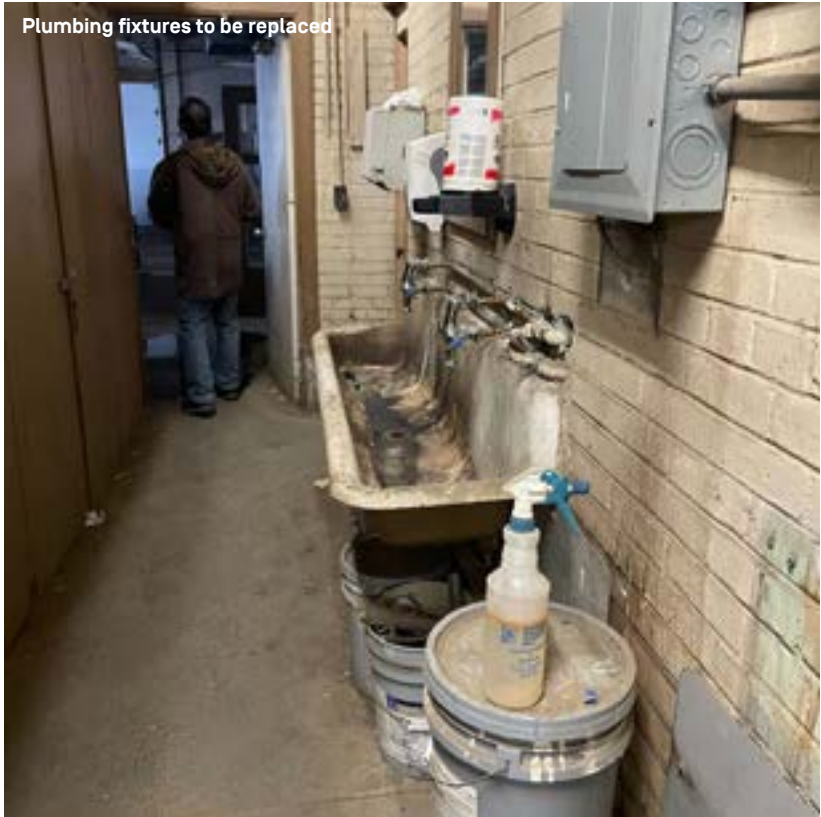
Plumbing fixtures to be replaced

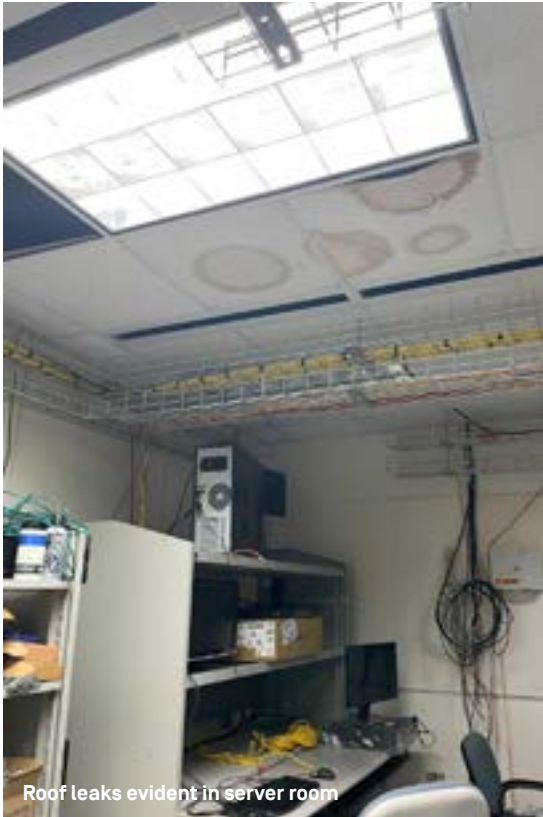
Roof leaks evident in server room
