FEBRUARY 21, 2022 // FACILITIES ASSESSMENT

OKEMOS PUBLIC SCHOOLS

TowerPinkster
ARCHITECTURE • ENGINEERING • INTERIOR

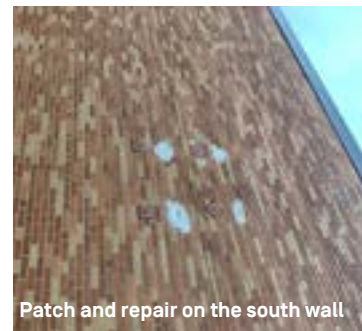
Patch and repair on the south wall

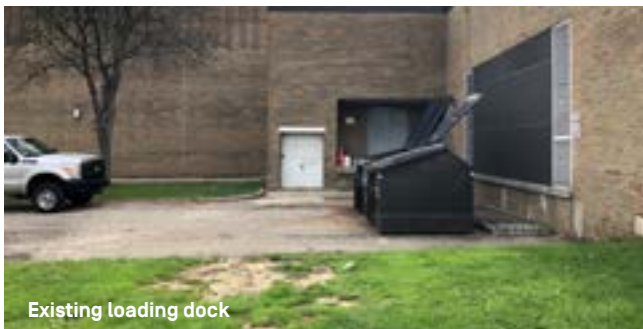
Pavement at parent drop-off locations is in poor condition. Loading dock pavement is in poor condition and the current loading area is insufficient to service the building. Exterior concrete 'retaining' walls and safety chains are in poor condition and present possible safety concerns for students. Considered removal and replacement. Maintenance staff mentioned the concerns regarding storm water runoff at the northwest ground level mechanical room entrance. Grading improvements and replacement of current door and frame should be completed. Tennis courts need to be replaced.

Existing loading dock

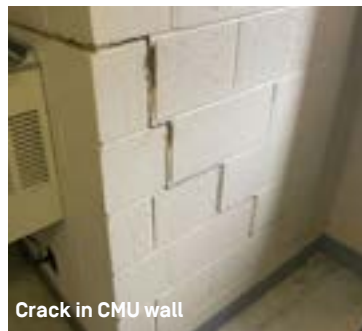
Crack in CMU wall
