FEBRUARY 21, 2022 // FACILITIES ASSESSMENT

OKEMOS PUBLIC SCHOOLS

TowerPinkster
ARCHITECTURE • ENGINEERING • INTERIOR

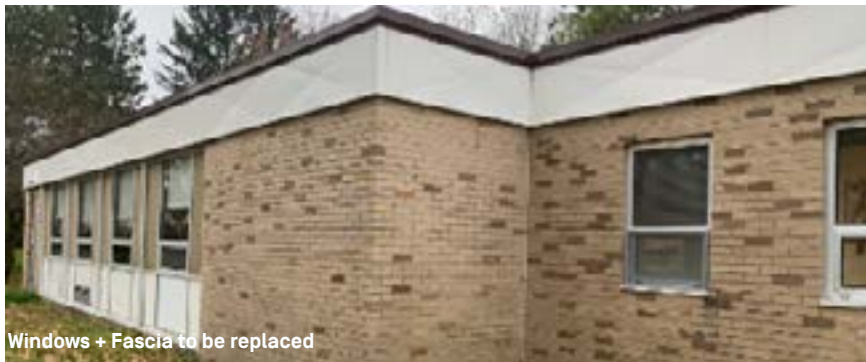
Exterior perimeter aluminum framing, windows, and glass should be updated with more thermally efficient products. Exterior perimeter metal fascia and roof gravel stop should be considered for replacement and updating. Roof leaks reported by maintenance staff at various locations throughout the building. Mold and mildew present on exterior brick at both the exterior building which is where building gas service is located and also the 'addition' created off the north end of the cafeteria as cold storage. No interior fire suppression present at this facility.

Windows + Fascia to be replaced

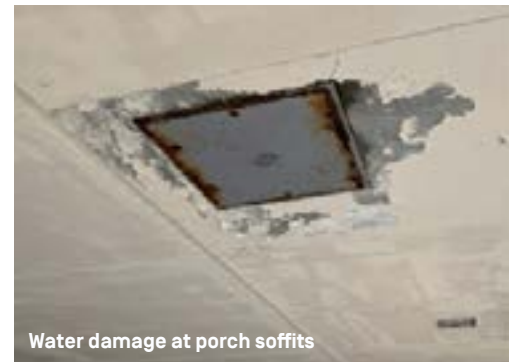
Water damage at porch soffits

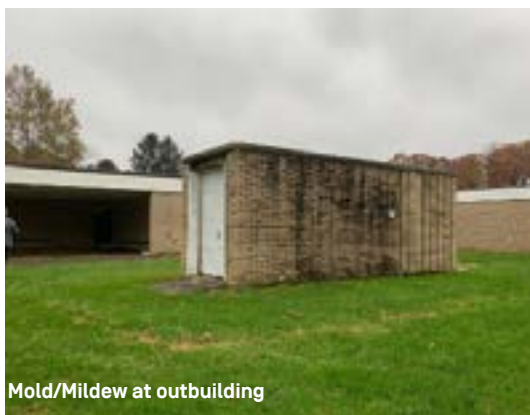
Mold/Mildew at outbuilding

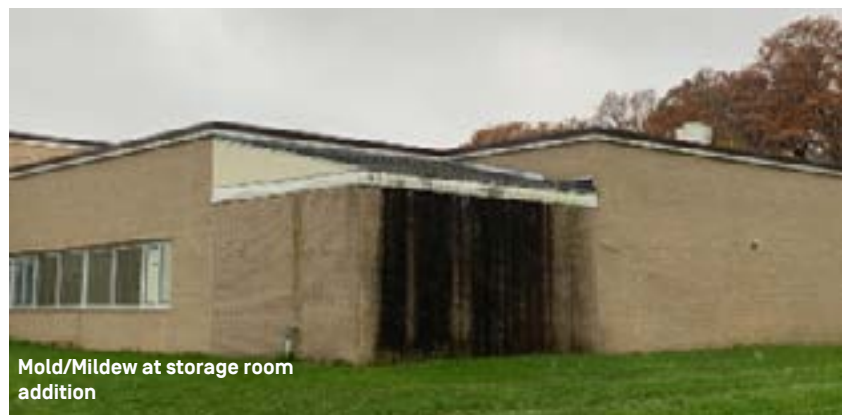
Mold/Mildew at storage room addition

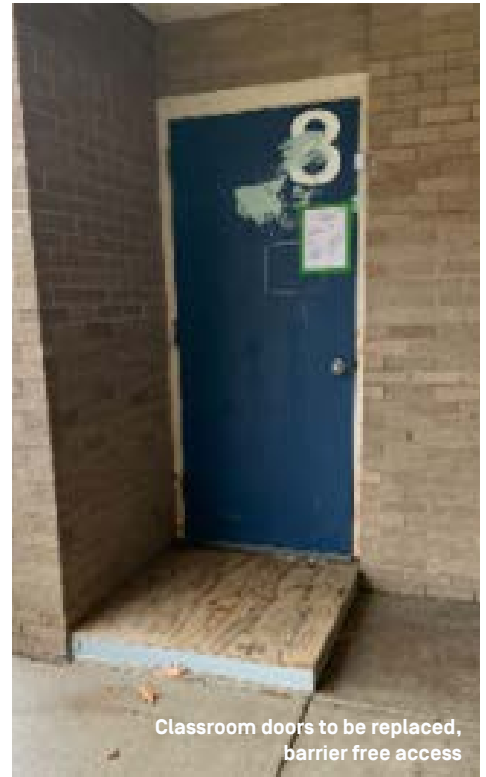
Classroom doors to be replaced, barrier free access

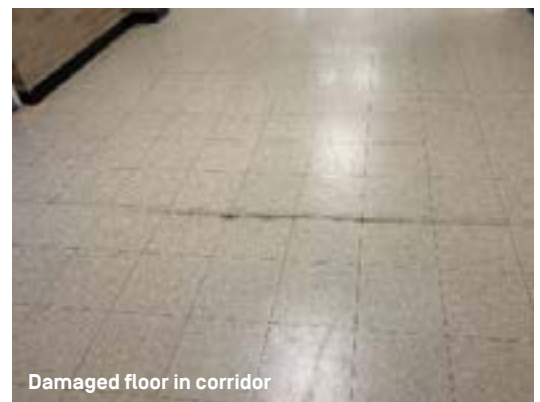
Damaged floor in corridor

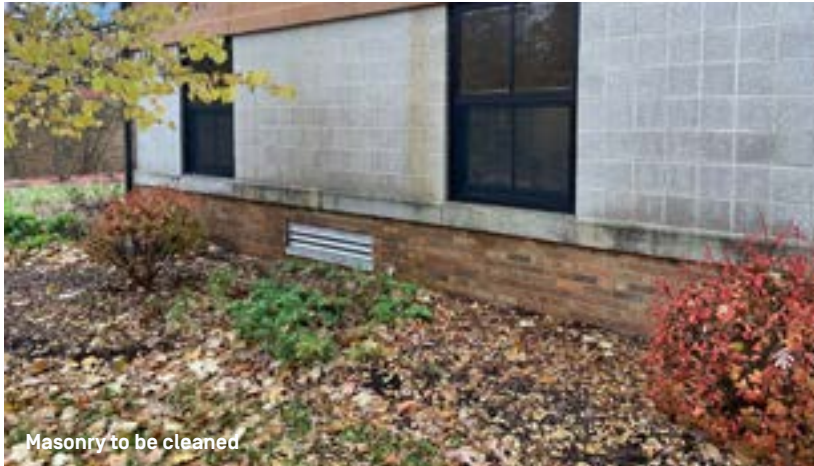
Masonry to be cleaned

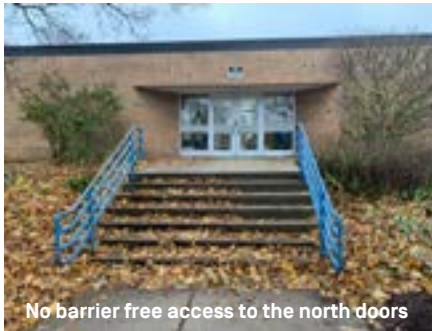
No barrier free access to the north doors

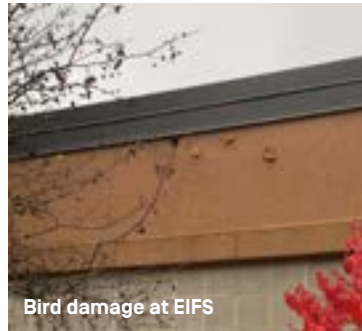
Bird damage at EIFS

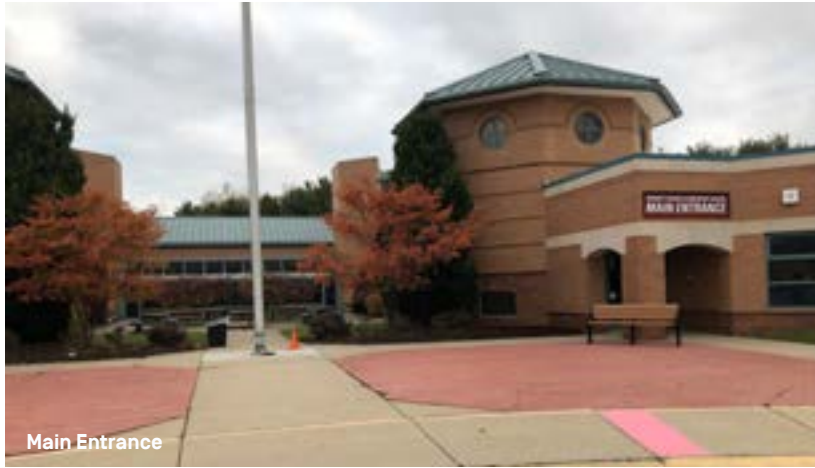
Stamped concrete at main entrance is cracked and should be replaced with snowmelt concrete. There are circulation conflicts between the parent drop-off and walkway from main parking lot. Existing screenwall at the loading dock is failing.

Main Entrance

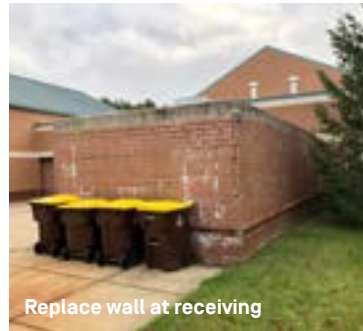
Replace wall at receiving

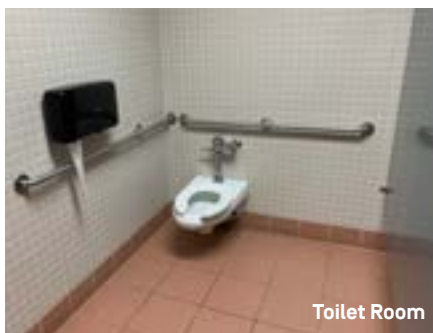
The classrooms added in the new addition are in good condition. Some of the multi-use toilet rooms were recently renovated with troweled epoxy flooring and wall tile floor-to-ceiling and are in good condition. Many still need to be renovated. Furniture throughout the building is dated and of poor quality, not conducive to a flexible or comfortable learning environment for staff or students.

Toilet Room

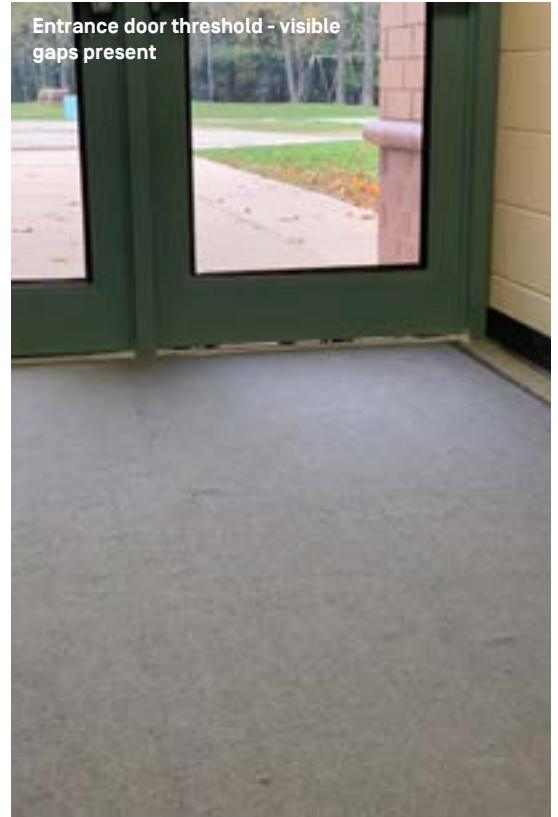
Entrance door threshold - visible gaps present

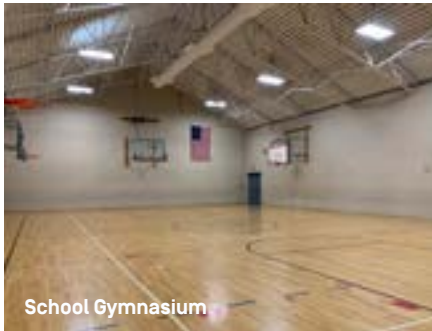
The wood floor in the Gymnasium is in good condition. The walls should have wall padding added behind the backboards. The exposed ceiling should be cleaned. The Art room has a newer VCT floor, but it is damaged due to lack of proper finishing and should be replaced.

School Gymnasium

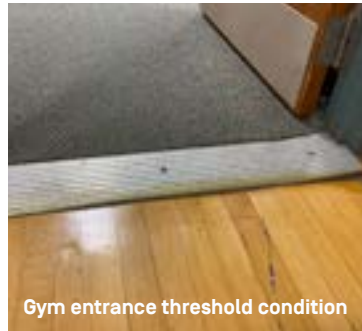
Gym entrance threshold condition

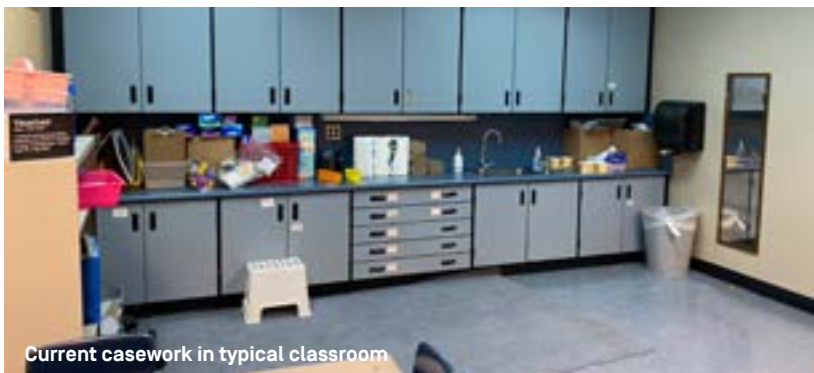
Classroom casework is damaged in some classrooms. Hardware is coming off, edgebanding is coming off and laminate doors are chipped. Countertops have been water damaged and are expanding severely at sink locations. Wood doors are in good condition with key code access hardware. Interior signs are present, but are not consistent or cohesive throughout the building. Wayfinding signage is lacking.

Current casework in typical classroom

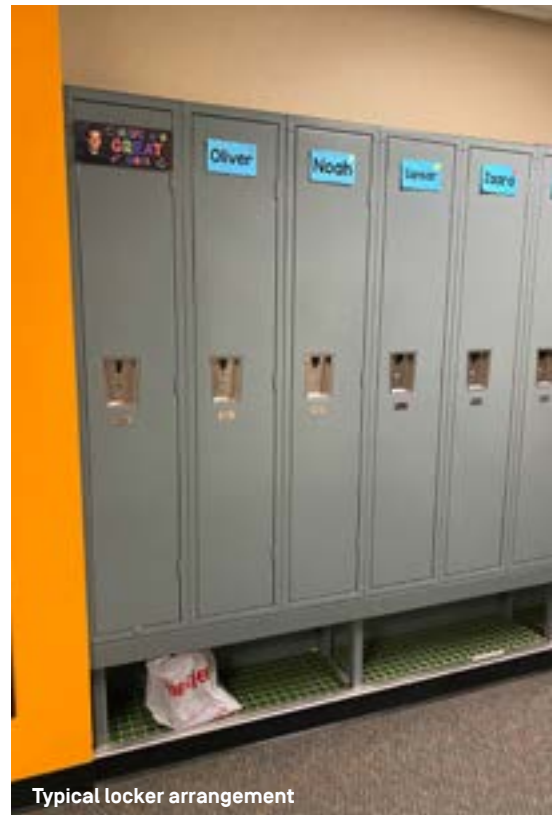
The carpet throughout is in need of replacement. It is original to the building worn and/or stained and coming apart at the seams in some areas. Corridor walls are finished with a multi-spec coating which is damaged in many areas and not easily repaired. Corridor lockers are in decent condition with a boot trough below.

Typical locker arrangement

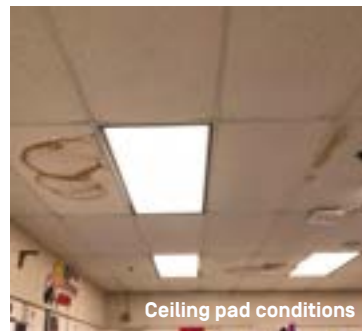
Ceiling pad conditions

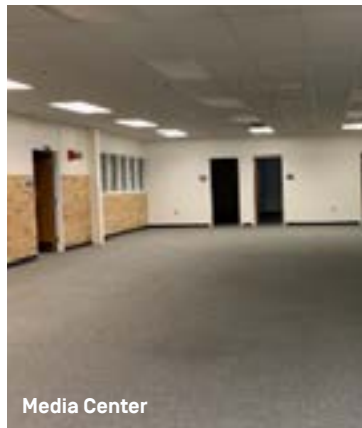
No vestibules at secondary entrances

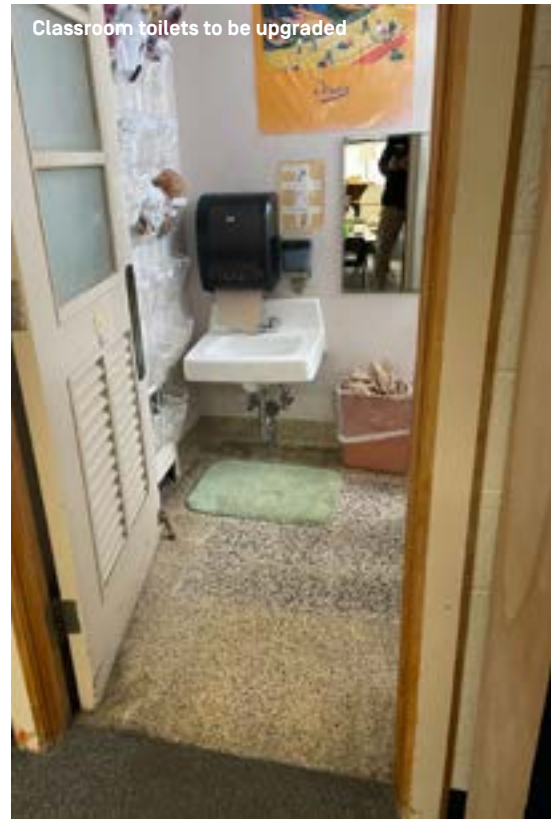
Classroom toilets to be upgraded

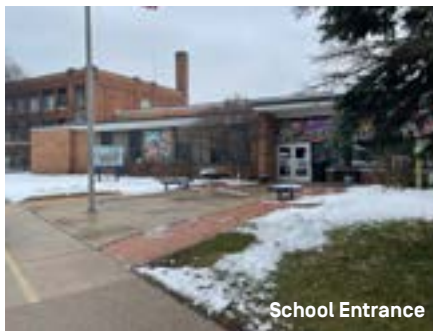
Sidewalks in poor condition CMU to be repainted

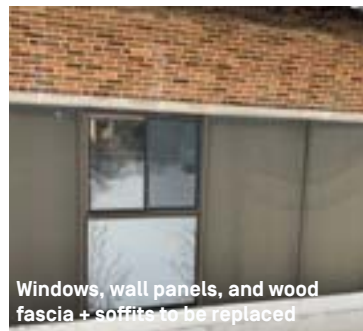
Windows, wall panels, and wood fascia + soffits to be replaced

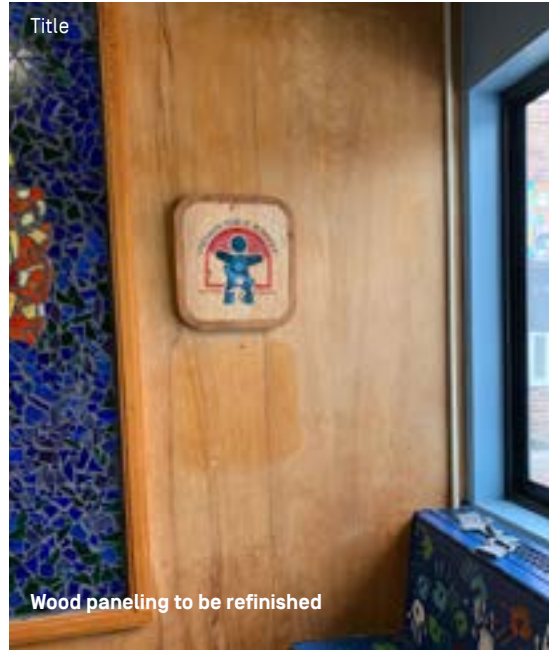
Wood paneling to be refinished

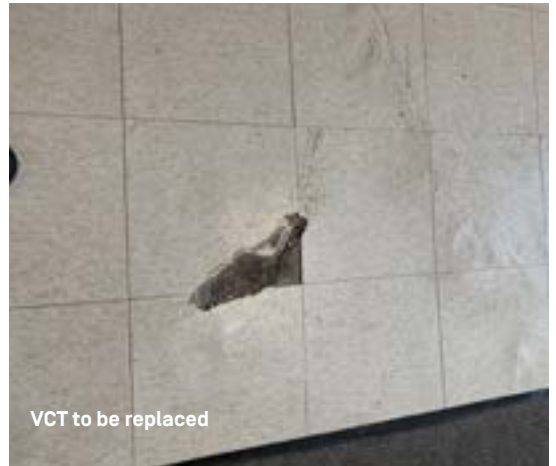
VCT to be replaced

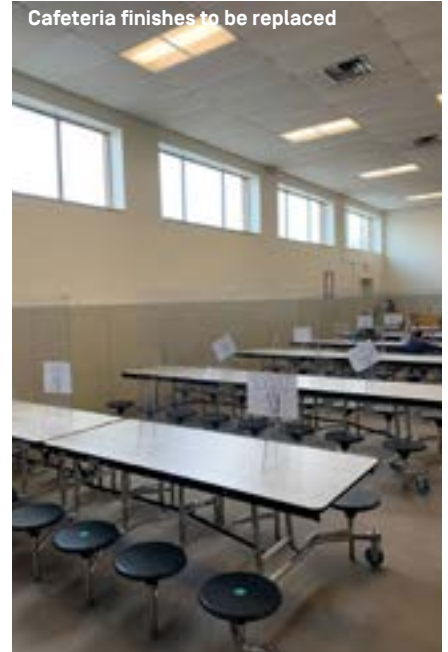
Cafeteria finishes to be replaced

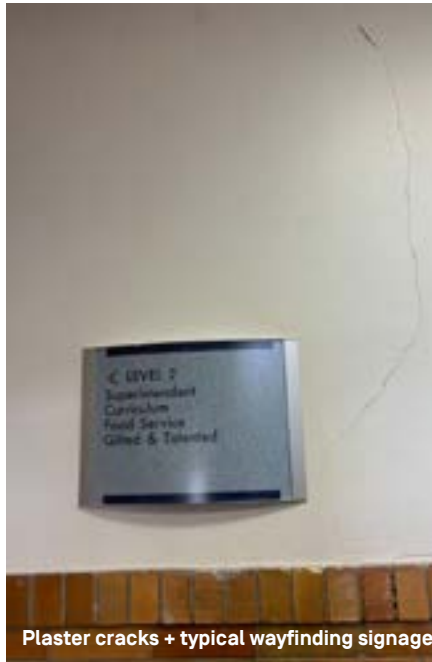
Plaster cracks + typical wayfinding signage

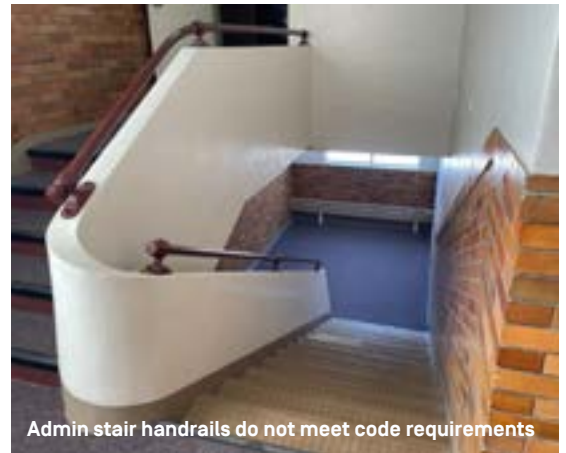
Admin stair handrails do not meet code requirements

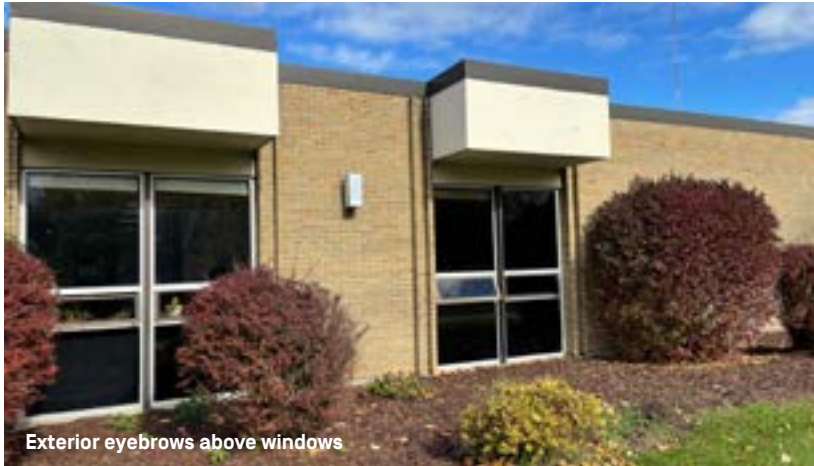
Exterior eyebrows above windows

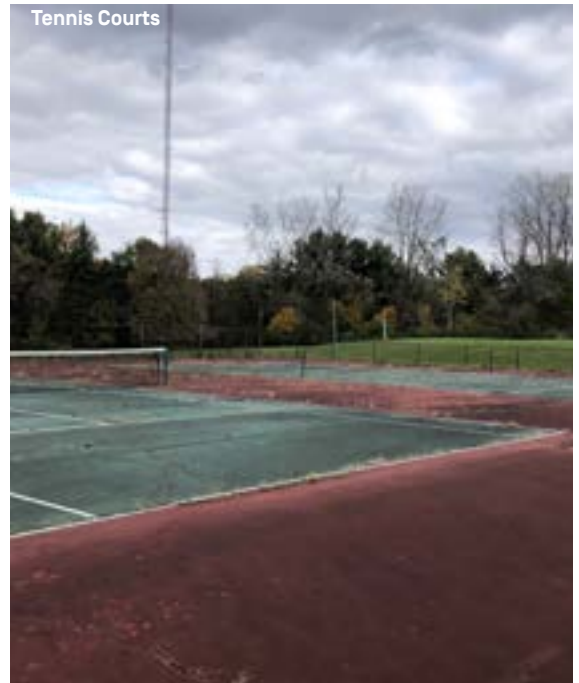
Pavement at parent drop-off locations is in poor condition. Loading dock pavement is in poor condition and the current loading area is insufficient to service the building. Exterior concrete 'retaining' walls and safety chains are in poor condition and present possible safety concerns for students. Considered removal and replacement. Maintenance staff mentioned the concerns regarding storm water runoff at the northwest ground level mechanical room entrance. Grading improvements and replacement of current door and frame should be completed. Tennis courts need to be replaced.

Tennis Courts

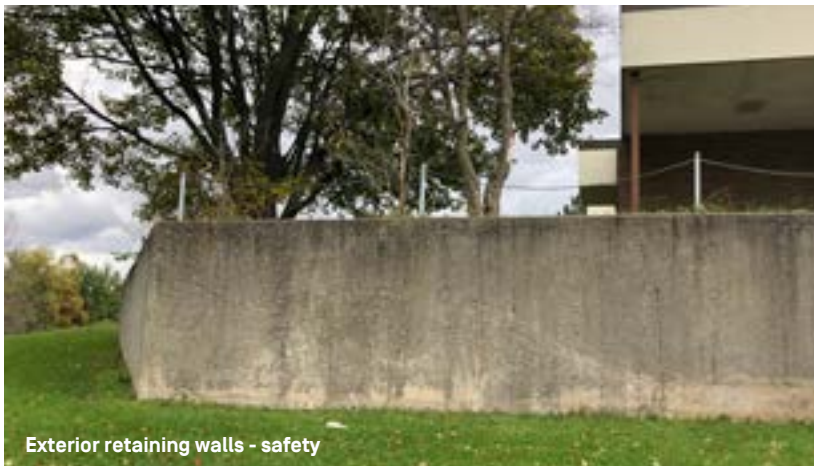
Exterior retaining walls - safety

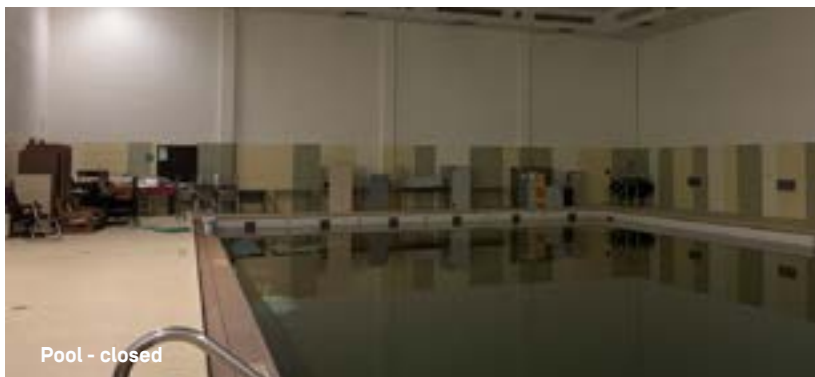
Pool - closed

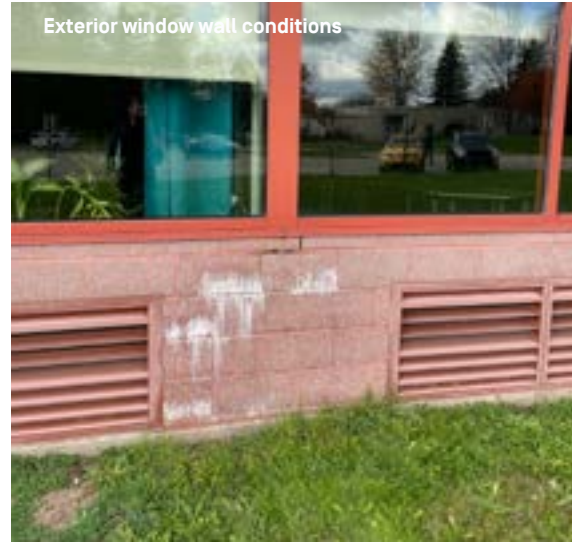
ARCHITECTURAL (CON'T)				comments
	good	fair	poor	
Exterior Windows		x		Some original windows have been replaced with special lite 'orange' storefront frames which are in good condition. Notice areas in wings. Recommend replacing remaining aluminum windows.
Positive Drainage		x		
Defined Entry			x	Main entrance not well defined or visible from the street. Recommend relocating the main entrance and office to the Kinawa Dr. entrance (currently
Accessibility		x		
Fascia/Soffits		x		Need to repair the coping/gravel stop fascia in some areas; soffits to be repainted
Brick / CMU		x		CMU at precast panel replacement locations showing signs of water intrusion - further investigation needed; CMU on south wall (Areas A & B) showing signs of water penetration below the window. Additions in northernmost wing not impressed with quality of exterior wall construction. Brick appears to be in good condition
Concrete Wall Panels			x	wall panels dirty/discolored - recommend cleaning or staining walls as appropriate

Exterior window wall conditions

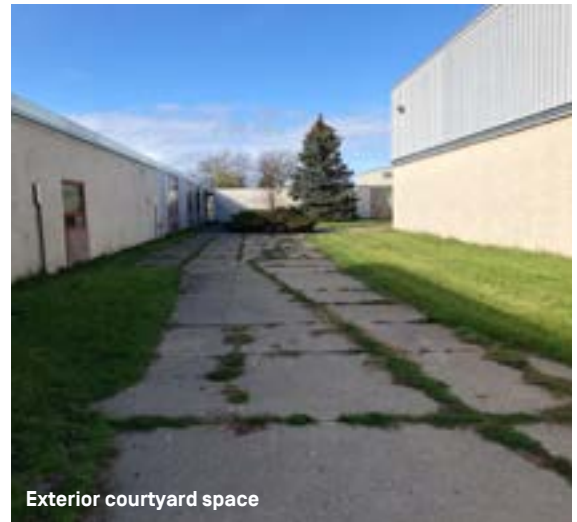
Exterior courtyard space

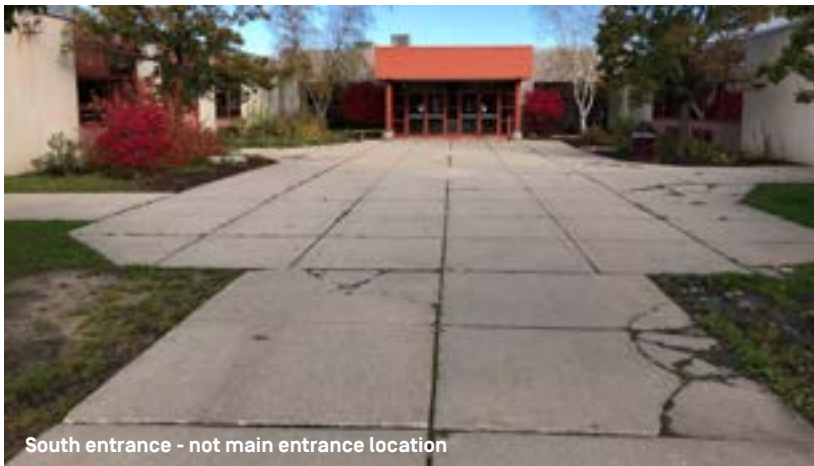
Main entrance currently located on the east elevation of the school, directly adjacent to the main parking lot. Long distance from closest parking spaces to main entrance. Could be a hindrance for some visitors. The entrance is marked only by a small directional sign – no canopy to provide definition. The exterior design and materials of the building are not inviting. Secure vestibule present. Interior and exterior locations of hollow-metal frames and glass should be considered for replacement. Non-thermally broken framing and glass present at the main office area and some corridor locations. Consideration for upgrades and replacement are necessary. The team noticed some water infiltration at exterior window sills, and brick efflorescence present on the wall below most exterior windows. Noticed multiple locations where roof gravel stops conditions could be improved or repaired around the perimeter of the building. Further investigation needed to understand if water infiltration and damage present at these locations. In addition to the main classrooms, the school has a media center, gym, kitchen, cafeteria, auditorium and dedicated area for the Community Senior Center. The Senior Center has a dedicated parking lot with entrance off the southeast corner of C-wing just south of the auditorium. Current condition of the auditorium became a point of discussion on our site visit as an area to be further analyzed as a candidate for full removal or high level interior renovation of existing space.

South entrance - not main entrance location

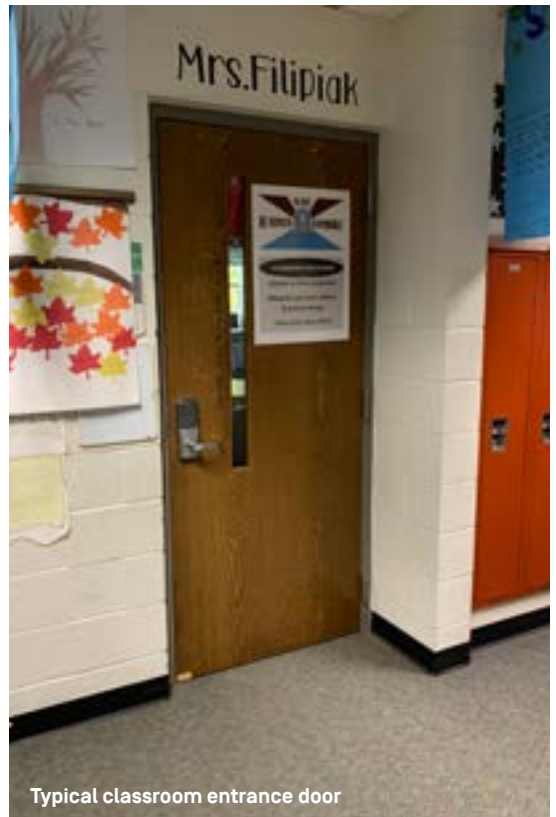
Ceilings are in fair to poor condition. The majority of the panels are 24" x 48" are showing signs of age and warping. Wood doors are in fair to poor condition.

Typical classroom entrance door

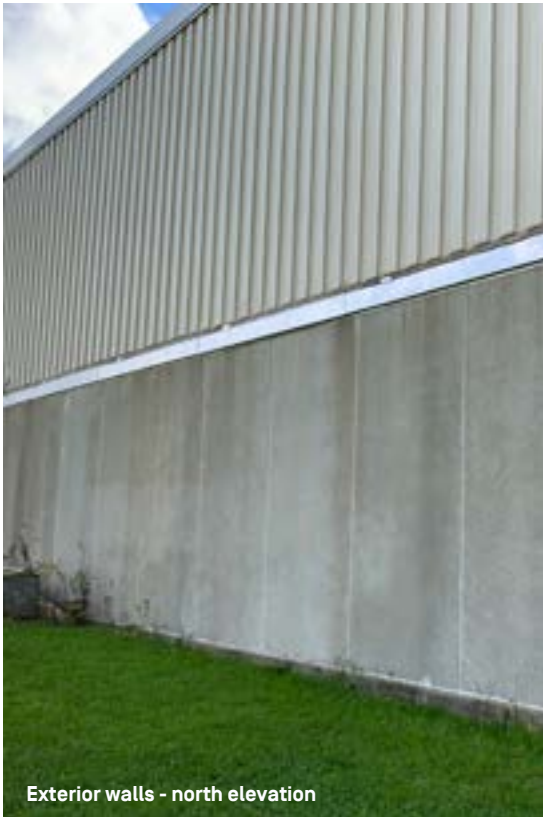
Exterior walls - north elevation

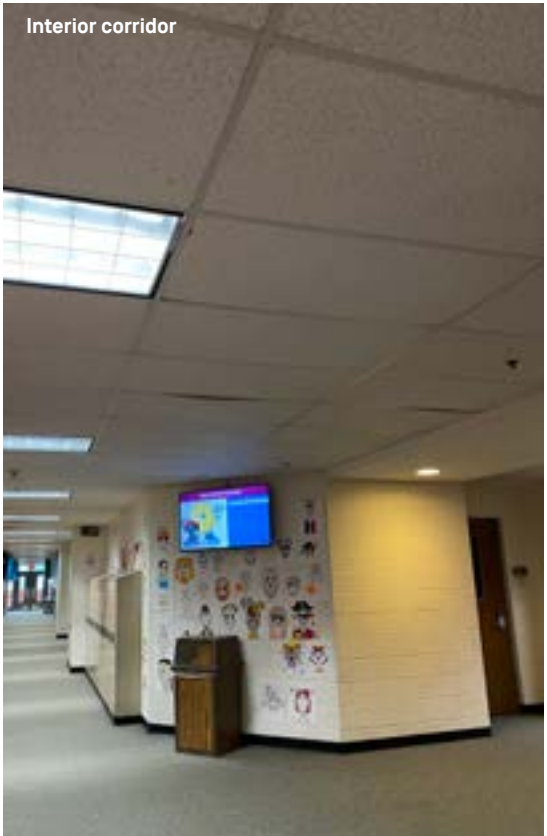
Most walls are painted CMU and are in good to fair condition. Corridor lockers should be considered for replacement.

Interior corridor

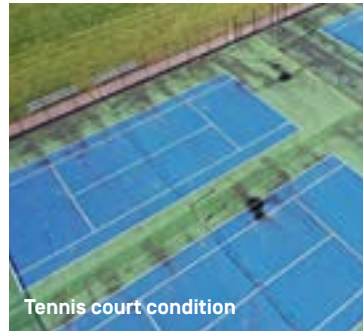
Tennis court condition

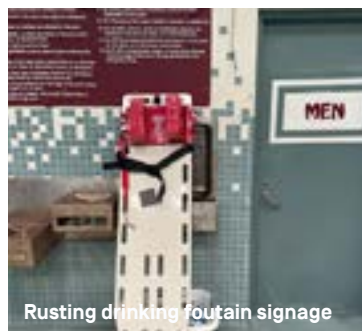
Rusting drinking fountain signage

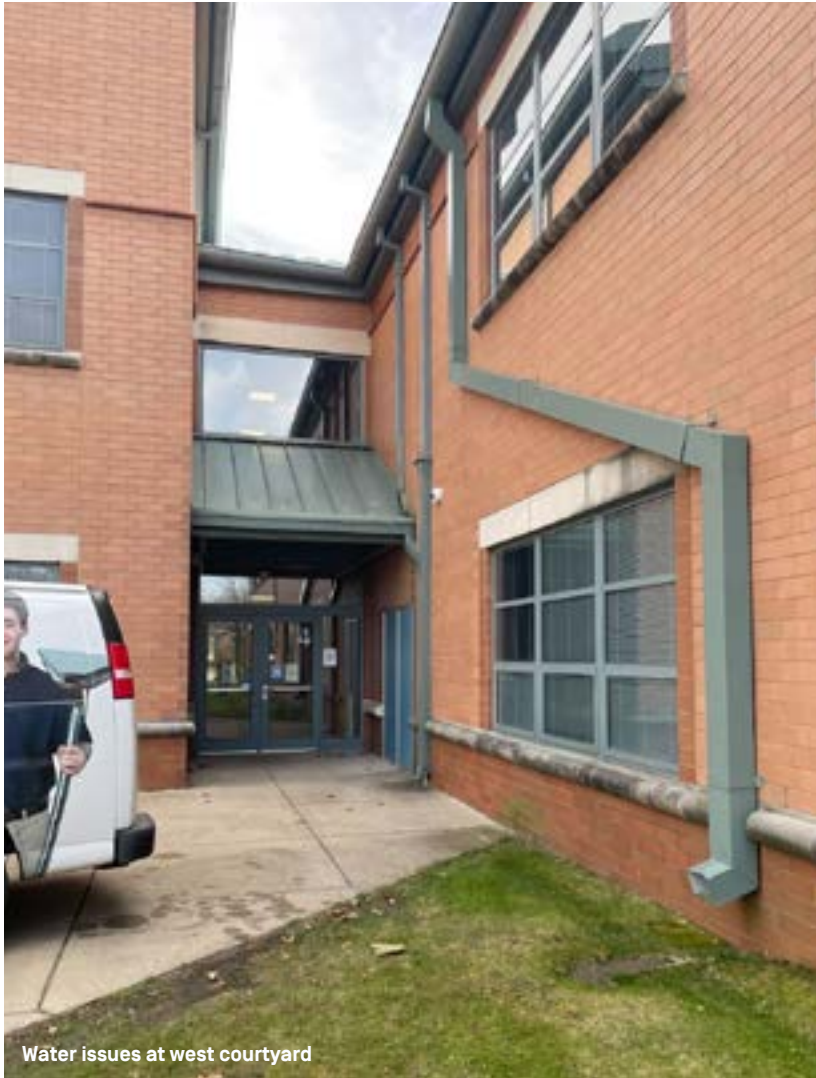
Water issues at west courtyard

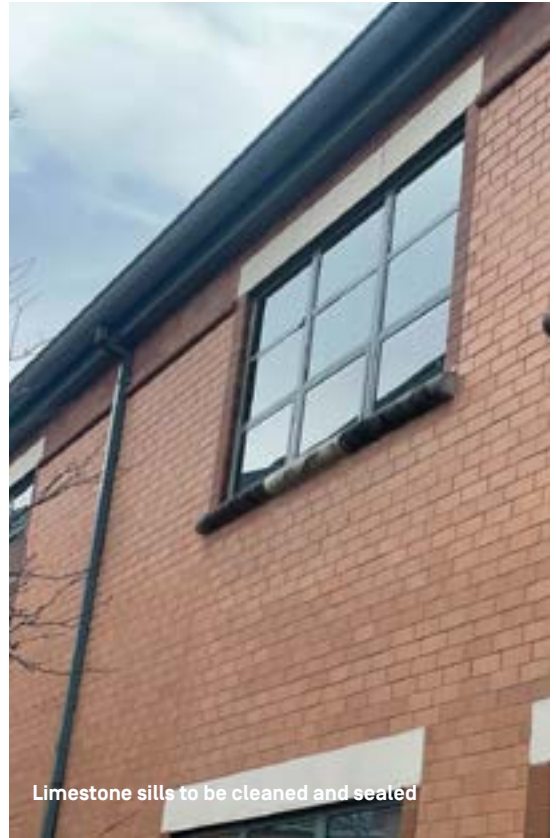
Limestone sills to be cleaned and sealed

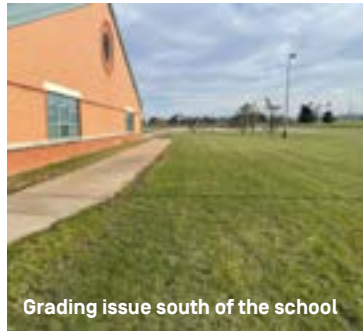
Grading issue south of the school

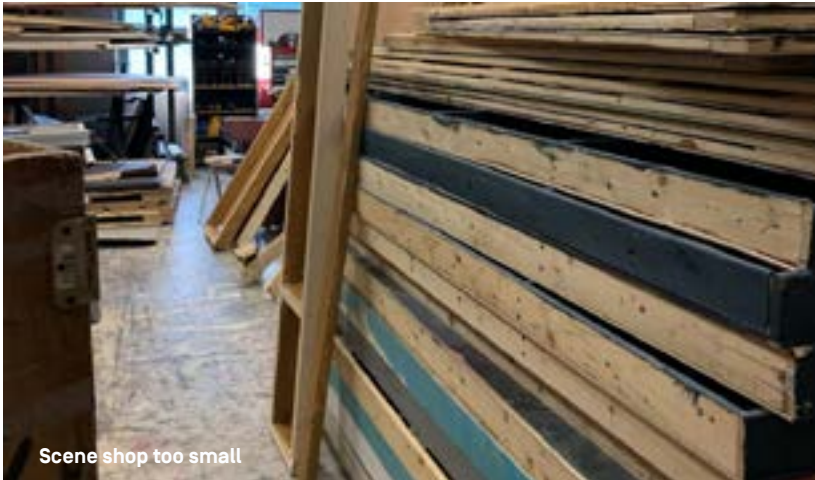
Scene shop too small

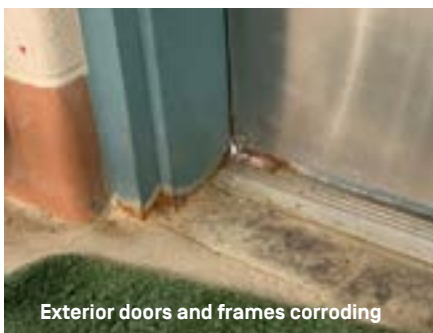
Exterior doors and frames corroding

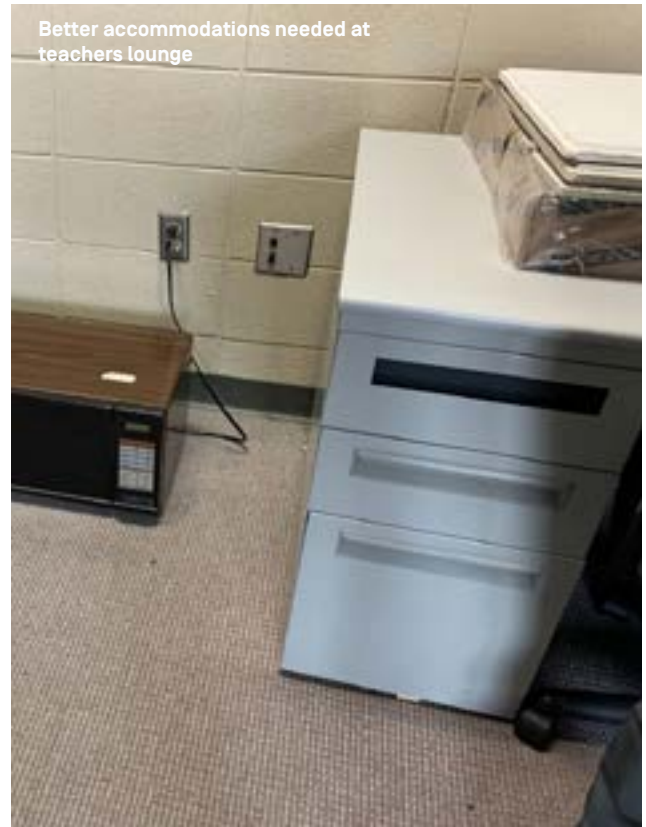
Better accommodations needed at teachers lounge

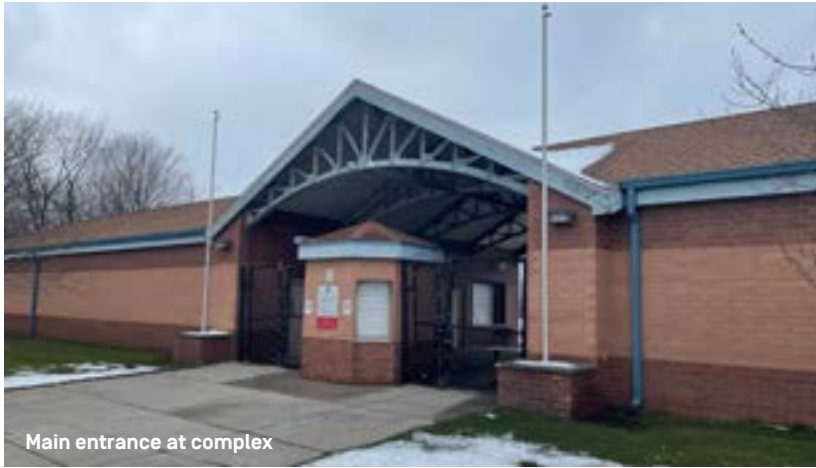
Main entrance at complex

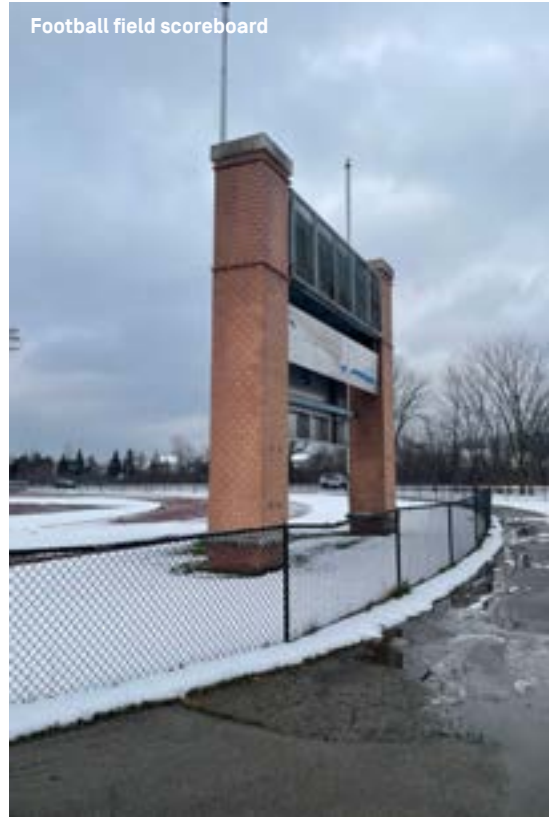
Football field scoreboard

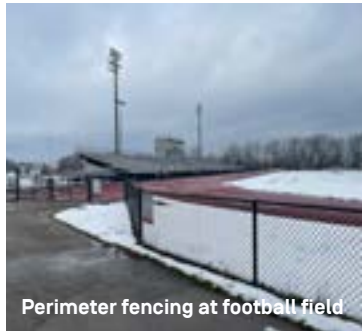
Perimeter fencing at football field

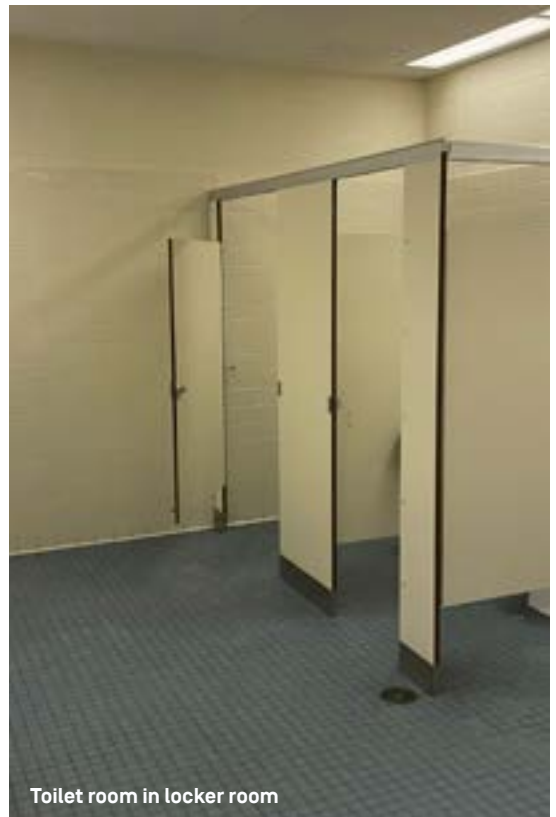
Toilet room in locker room

Bathroom(s)		x		Plumbing fixtures, tile, toilet partitions, showers, mirrors, countertops are all functional but dated. Consider updates.
Locker Rooms		x		Replace flooring, ceilings, and lighting. Walls and existing lockers in good condition. District mentioned they need more storage inside of athletic complex.
Fields			x	Issue noted with ADA access/sidewalks from parking lots to fields complex. Long distance from parking lot to BB/SB/Soccer fields and not currently ADA accessible. ADA safe access does not exist from High School to the Athletic complex. Football field has recent turf and track updates. Tennis courts and perimeter fencing needs to be replaced. Baseball and Softball fields need new fencing and dugouts.
Exterior Doors & Fencing			x	Consider exterior door replacement/rusted frames and doors. Most of the fencing (black chain link) needs to be removed and replaced.

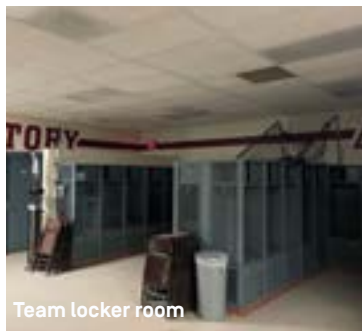
Team locker room

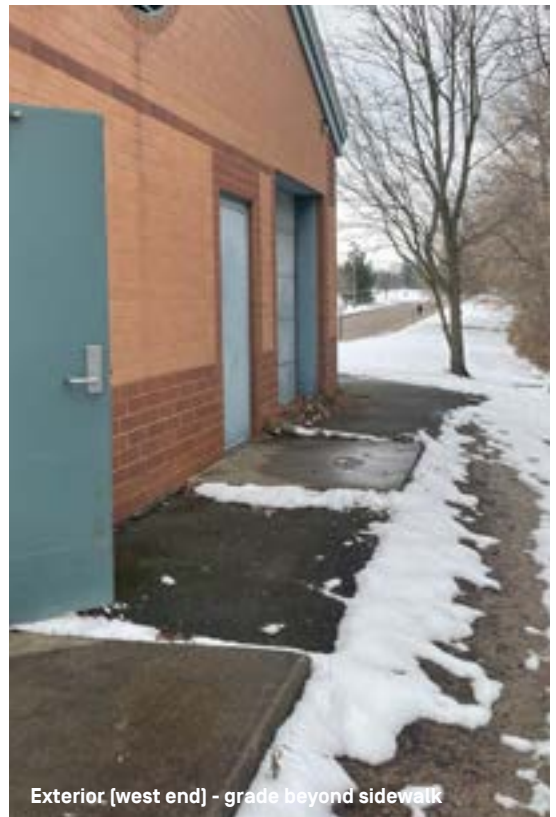
Exterior (west end) - grade beyond sidewalk

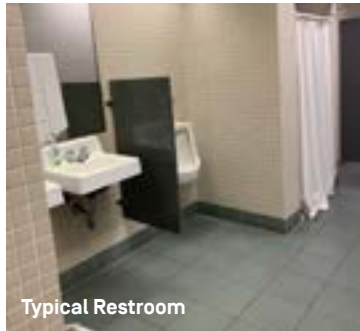
Typical Restroom

Replace unit heaters, rooftop unit (4-ton), and make-up air units (3-4,300 cfm, 2-1,100 cfm). All exhaust fans need to be replaced. Upgrade DDC system. Add trench drain to bus service area. Replace water heater and plumbing fixtures.

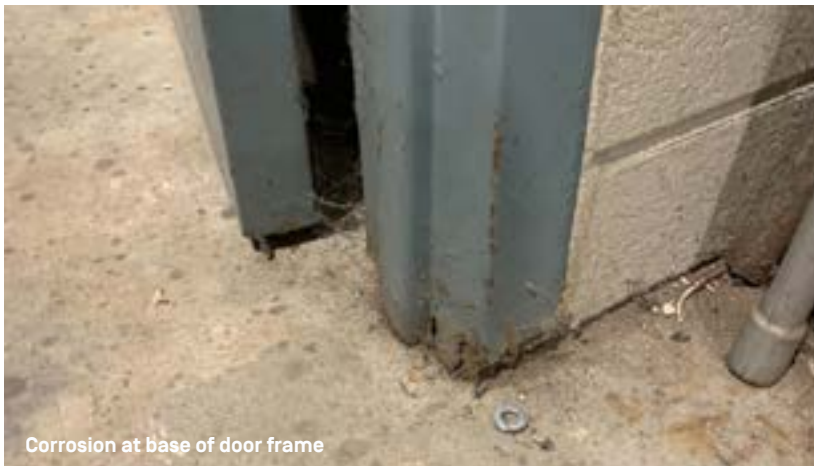
Corrosion at base of door frame

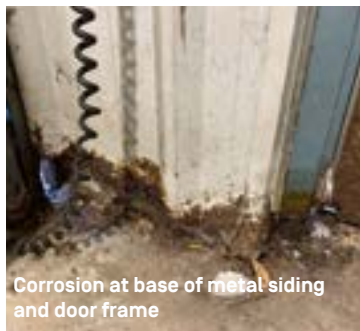
Corrosion at base of metal siding and door frame

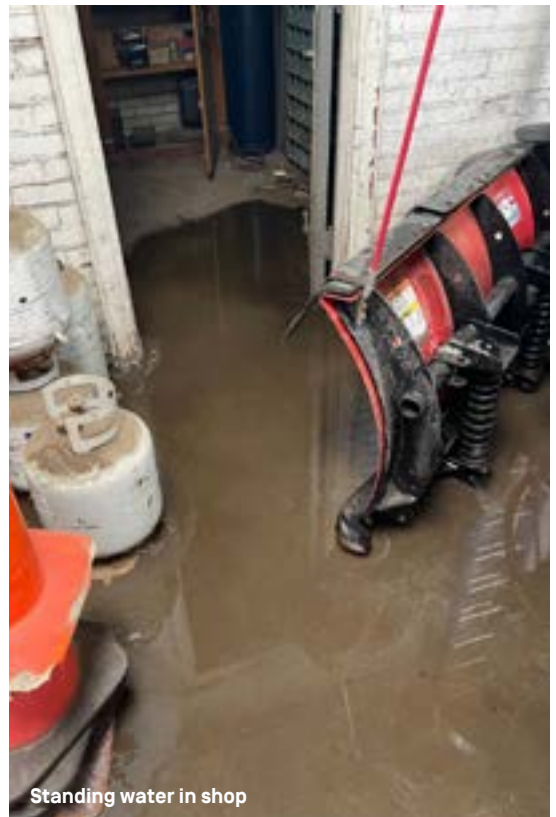
Standing water in shop

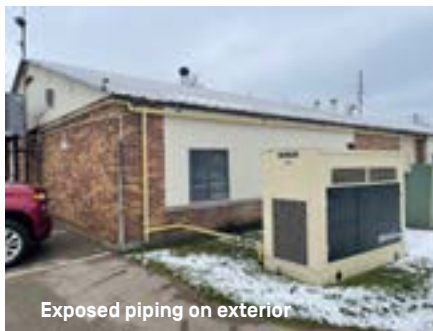
Exposed piping on exterior
